FALL 2003

Flight Comment

The Canadian Forces Flight Safety Magazine

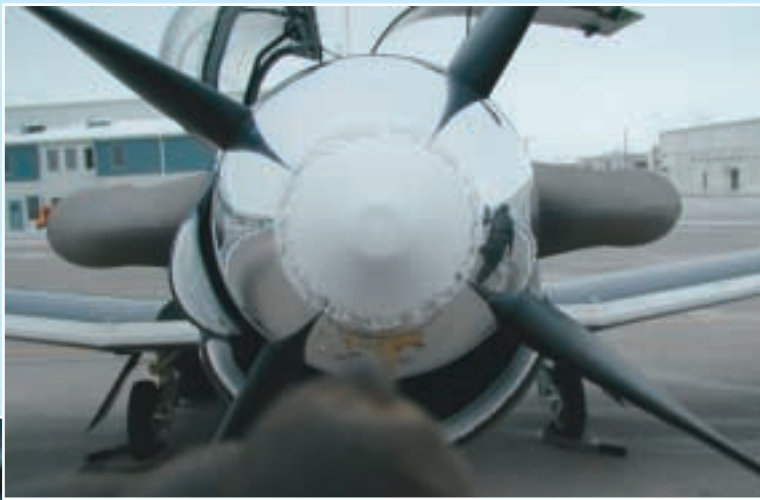
Figure 1

to do this can have disastrous consequences on aircraft performances and handling characteristics. Small deformations of the wing contour due to ice, snow, or from other provenance can have a large impact on the aircraft stall characteristics. Figures 1 and 2 demonstrate what happens after a limited exposure to icing conditions. The ice formed on this aircraft drastically increased the stall speed. The clean wing concept, thus, assures the pilot that the aircraft will operate safely, as it should. It must be emphasised that the de-icing or anti-icing systems are designed to cope with cloud icing, not with freezing rain or drizzle.

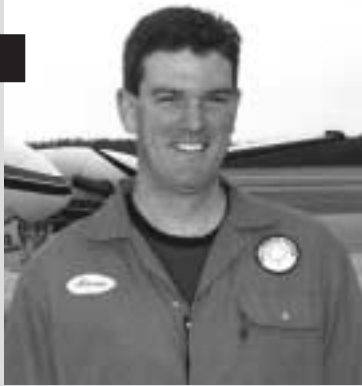
MR. AARON LEGGETT

While he was examining the wing attachment bolts and fittings, Mr. Leggett saw what appeared to be a hairline crack on the left lower forward wing spar attachment. He cleaned the area and carried out a liquid penetrant inspection. This particular

assessment proved what he had suspected. The defect was definitely a crack, radiating outboard and upward on the wing spar attachment lower fitting.

This area is not specifically within the scope of the inspection and is a difficult area to view clearly. This finding required that the main wing spar be replaced as well as a full re-inspection of the C-90A fleet and notification to Raytheon Aircraft and Transport Canada. The manufacturer has had no previous reports of defects of this nature in this area and is now in possession of the spar assembly to carry out further tests.

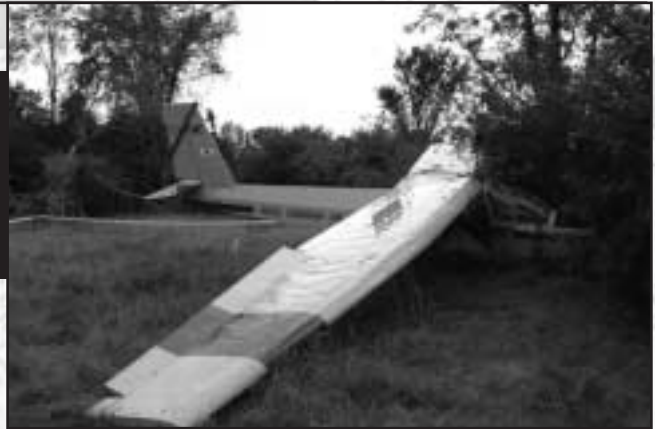
LOCATION: Picton, ON

The aircraft received "A" Category damage. Extensive damage to the left wing, particularly the leading edge, was noted. The outboard section of the left wing was folded forward in the horizontal. The right wing did not appear to have suffered damage externally, however, it did show evidence of severe skin deformation. Flight control surfaces on both wings were seized. The cockpit remained intact and its habitable space was not compromised. Minor cracking of the overhead cockpit canopy and numerous punctures of the glider's skin were noted. The tail section's skin and longerons were deformed.

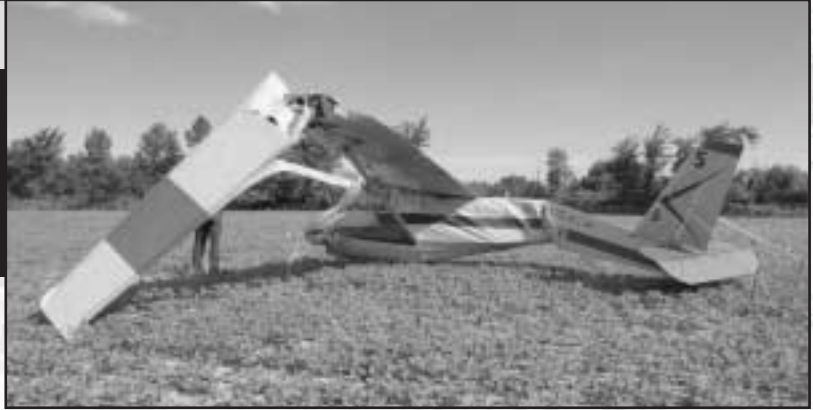
LOCATION: St-Jean, Quebec

The aircraft received A Category damage. Both wing tips contacted the ground, the left wing broke in two pieces at the inboard end of the aileron, and the underside of the nose cone was pushed inward. The right wing tip fairing received minor damage and the wing itself buckled at the inboard end of the aileron. The rear fuselage bent at the midpoint.

left in order to effect landing in a field to the left of the glider. During the turn the glider impacted the ground with the left wing, cartwheeled and came to rest in a recently sowed farmers' field. The instructor exited the glider so as to assist the student in getting out of the cockpit. A passing ambulance rendered medical assistance and transported both the instructor and student to the local hospital. Both suffered minor injuries.

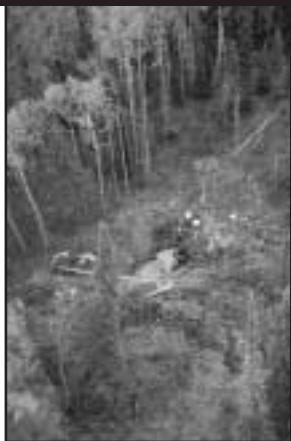
**LOCATION: Cold Lake Air Weapons Range (CLAWR),
40 Miles NNW of 4 Wing Cold Lake.**

The accident aircraft was the number three aircraft and part of the second four ship of an eight-plane Maple Flag mission launched from 4 Wing in Cold Lake AB. The four aircraft were in a “four ship card” formation. They had completed their simulated weapons delivery and were approaching their exit target, flying relatively

level at about 480 knots and 3000 feet AGL. The number two aircraft had just closed to tight formation on the lead aircraft to inspect that aircraft for a possible gear problem. This put both of the leading pair of aircraft about 1.2 NM directly in front and slightly above the accident aircraft. When the accident aircraft reached the approximate point in space where the lead pair of aircraft had rejoined, it began a very fast negative G “barrel” roll to the right, completing a full roll in about 3.5 seconds. Although the aircraft roll rate slowed at wings level, the negative G continued and shortly thereafter the roll to the right commenced again. At about this time, with the aircraft in a negative G regime, the pilot initiated an ejection but he was fatally injured. The aircraft continued to roll under negative G, nosed down and impacted the ground inverted at about 45 degrees of pitch with a high bank angle and high velocity. It was destroyed on impact.

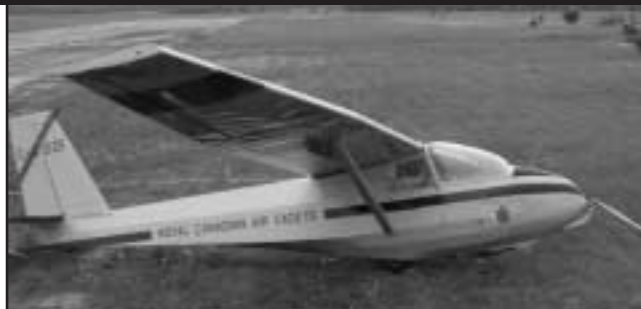
LOCATION: Picton, ON

The instructor pilot and the student were conducting a pre-solo training flight in the Central Region Air Cadet Gliding Scholarship Program when the glider struck the ground during the landing phase. Although the instructor received minor back injuries, the student was uninjured. The glider sustained "B" category damage.

The glider's right wingtip struck the ground first, followed by the glider's main skid. The impact caused the glider to rotate 30° to the right as it bounced into the air. After the second impact, the glider continued to rotate to the right as it slid across the wet grass landing strip, finally coming to rest approximately 90° from the direction of landing. Both occupants egressed under their own power.

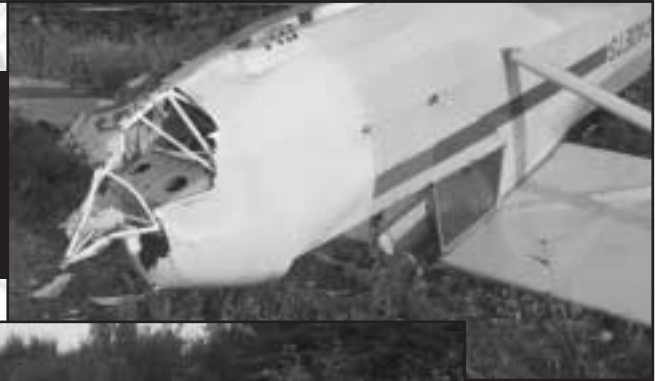
LOCATION: Debert, NS

The solo student was participating in the Atlantic Regional Gliding School program when the glider's left wing struck a tree during the turn to final. The glider then crashed and came to rest upside down. The cadet received minor injuries. The glider received "A" category damage.

Damage to the glider was severe. The outboard portion of the left wing was almost torn from the rest of the wing while the right wing suffered severe ground impact damage. The aircraft's nose was pushed in and shattered while the vertical stabilizer was severely crushed.
